## A Survey of Thatched Buildings in Scotland

Thatch Survey of Scotland  
2014-15

A photographic survey of thatched buildings in Scotland, surveyed between May 2014 and August 2015 by Zoe Herbert (SPAB Scotland Officer), on behalf of the Society for the Protection of Ancient Buildings.

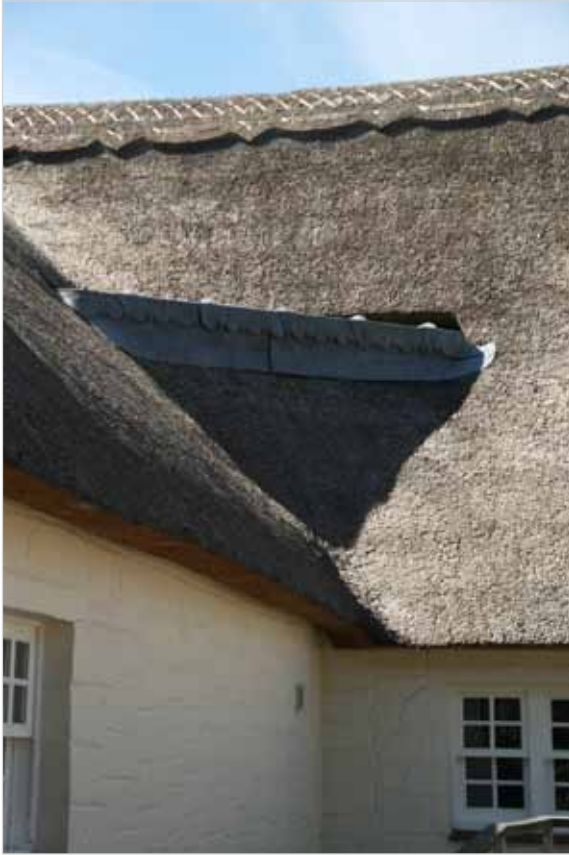
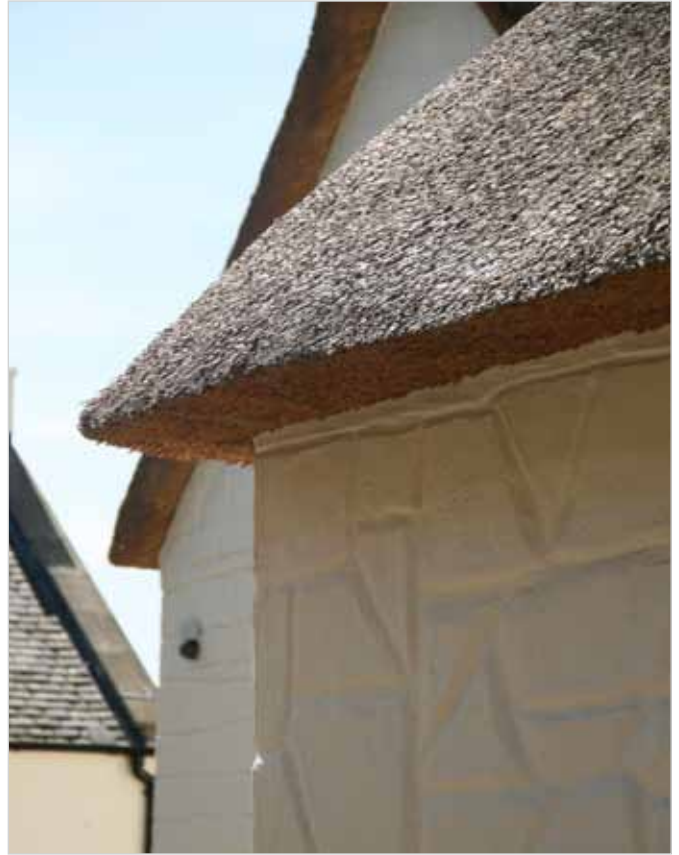
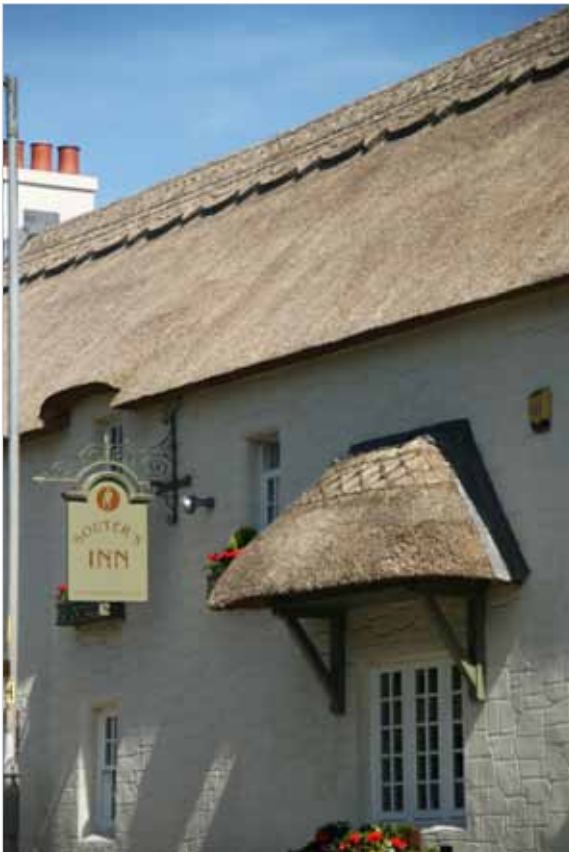
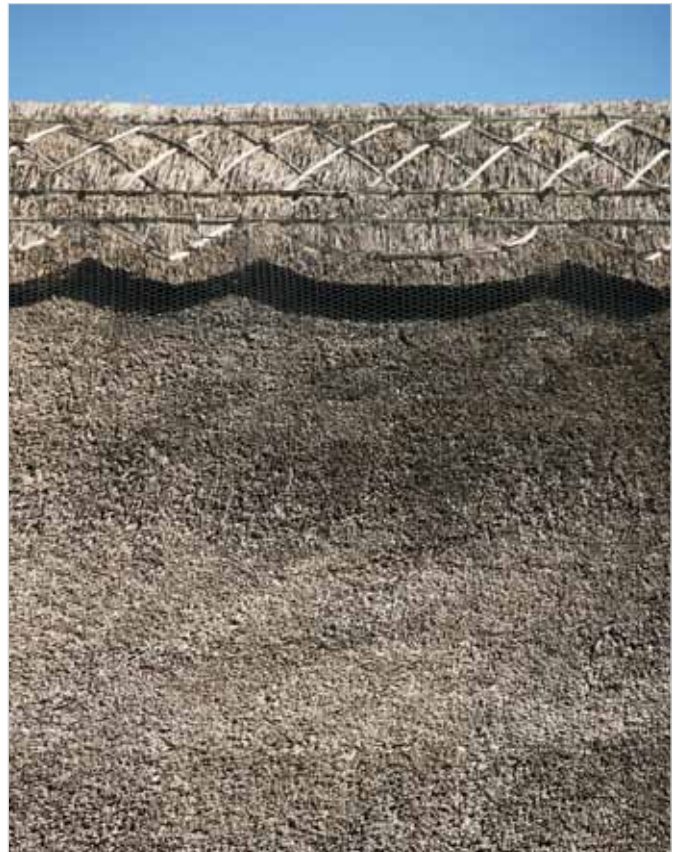
Souter's Inn – South Ayrshire

Thatch Type: ..... Reed  
Ridge Type: ..... Thatched (Reed)  
Condition of Thatch: ..... Good

**Additional Notes:** Restaurant building, apparently built on the site of the old school house where Robert Burns studied in 1775. The building was first thatched, following refurbishment, around five years ago, circa 2009. However, in early 2012 the thatched roof of the building caught fire and much of the thatch was destroyed. During the incident a section of the roof also collapsed. Following the fire, the damage to the building was repaired and the roof was re-thatched in 2013. The thatcher was based in England and the reed came from Belgium. A fireboard has been installed underneath the thatch and a magma spray has been used on top to prevent fire. The

raised ridge is scalloped, and scobed using hazel spars. The ridge is netted whilst the rest of the thatch is left uncovered. On the north elevation, the roof is hooded at the eaves above two first-floor window openings. There is also a thatched awning above a ground-floor window on the north elevation, which is scobed and netted at the top.

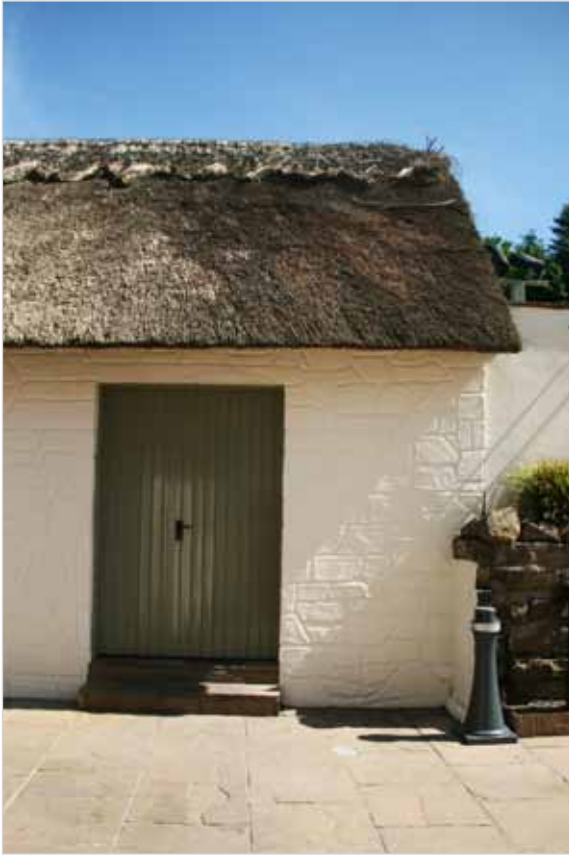
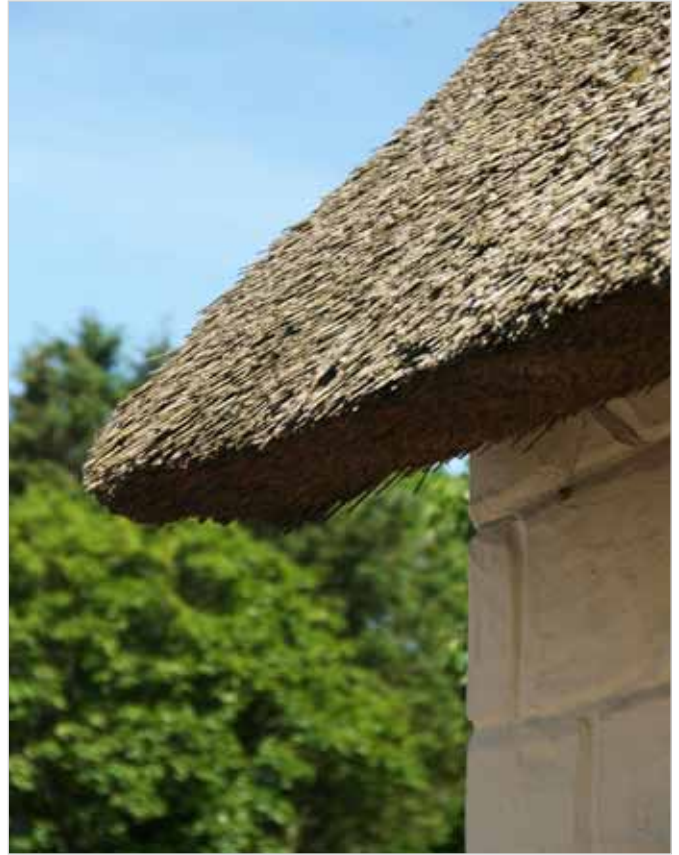
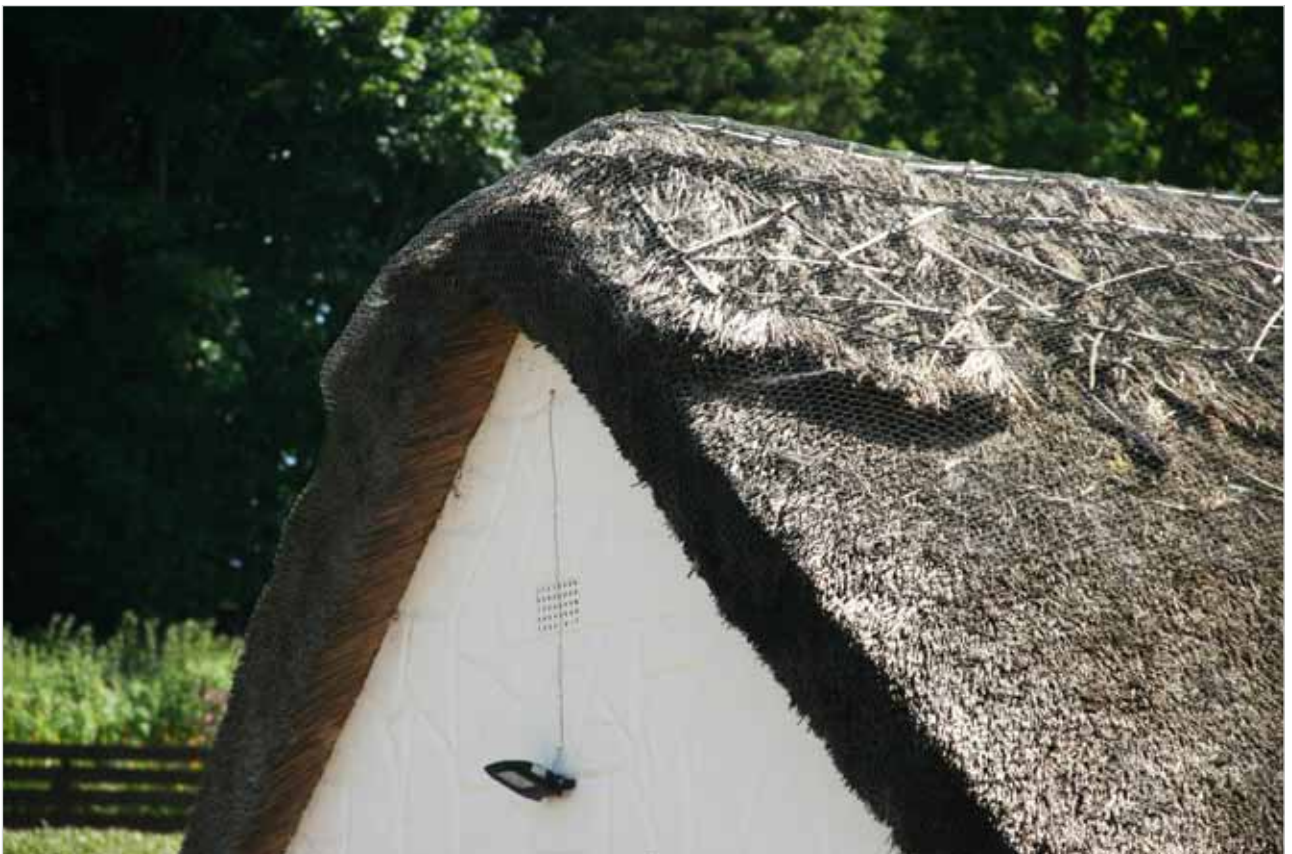
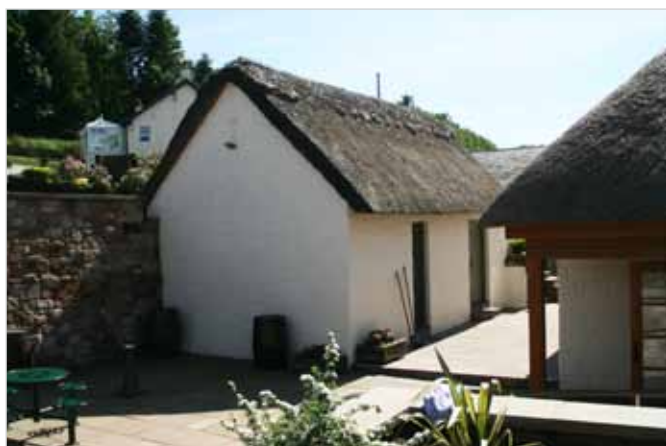
Souter's Inn Larder – South Ayrshire

Condition of Thatch: ..... Fair

**Additional Notes:** ..... The building was thatched circa 2009. In April 2012 the thatched roof of the main building of Souter's Inn caught fire (Survey Number 201). According to the owner, the larder building is located between the part of the roof that was on fire and the car park where the fire engines needed to park in order for the hoses to reach the fire. The hoses needed to be taken over the roof of the larder and subsequently the scobed ridge of the building was damaged. The ridge, and just below the ridge, has since been netted to protect the damaged thatch or any of the hazel spars from the becoming dislodged and falling off. Due to the high cost of re-thatching

..... Souter's Inn after the fire, the ridge on the larder building was not deemed urgent at this time. The roof remains watertight despite the damage. The owners plan to have the ridge fixed at some point next year. The thatch below the ridge is in good condition and has only a very small amount of mossy vegetation growth in places.

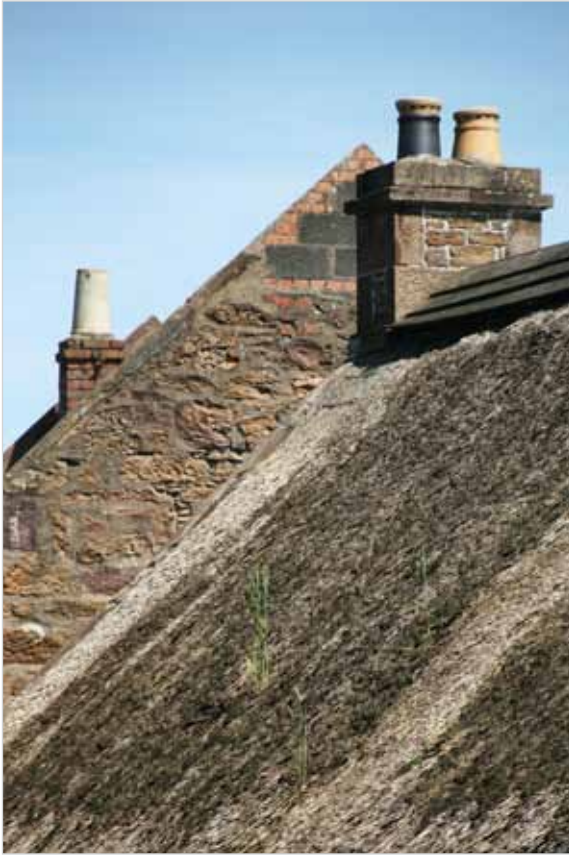
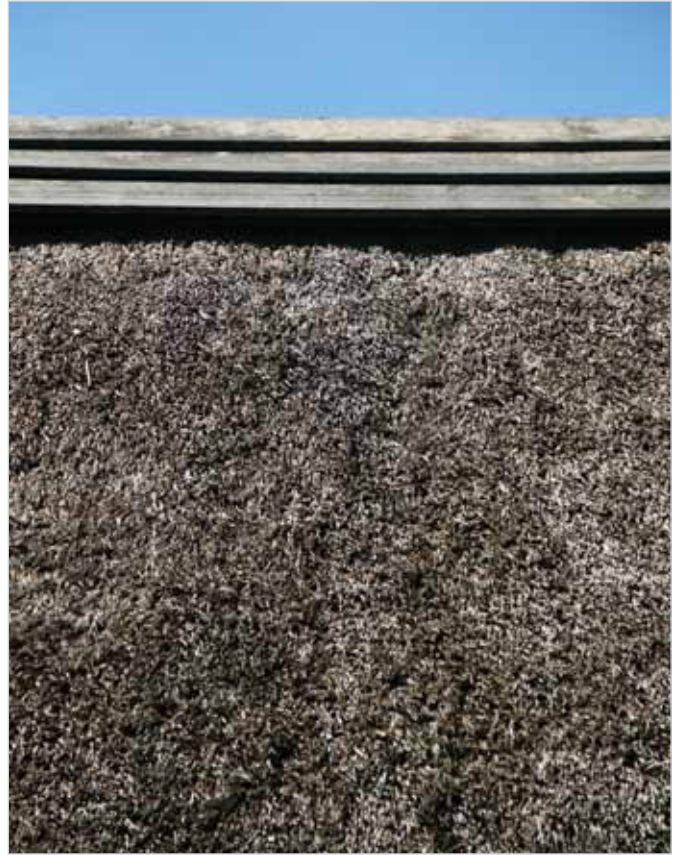
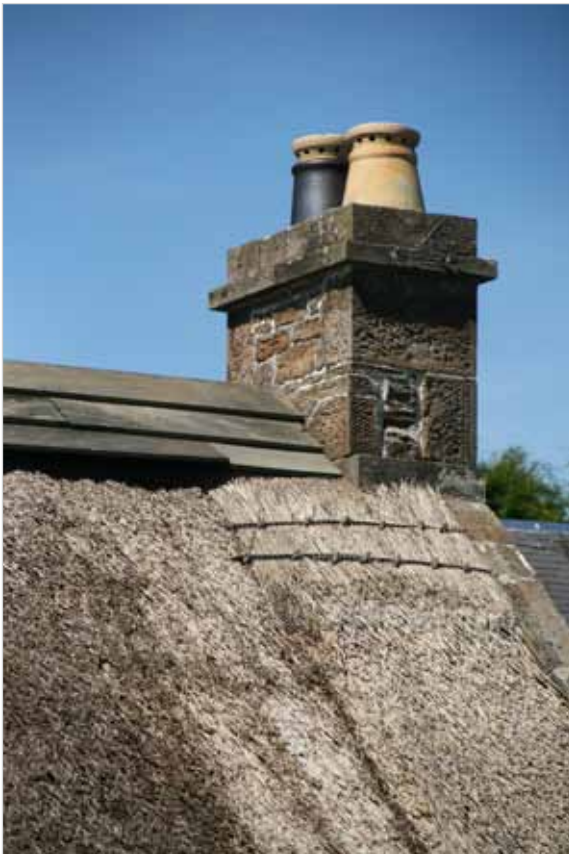
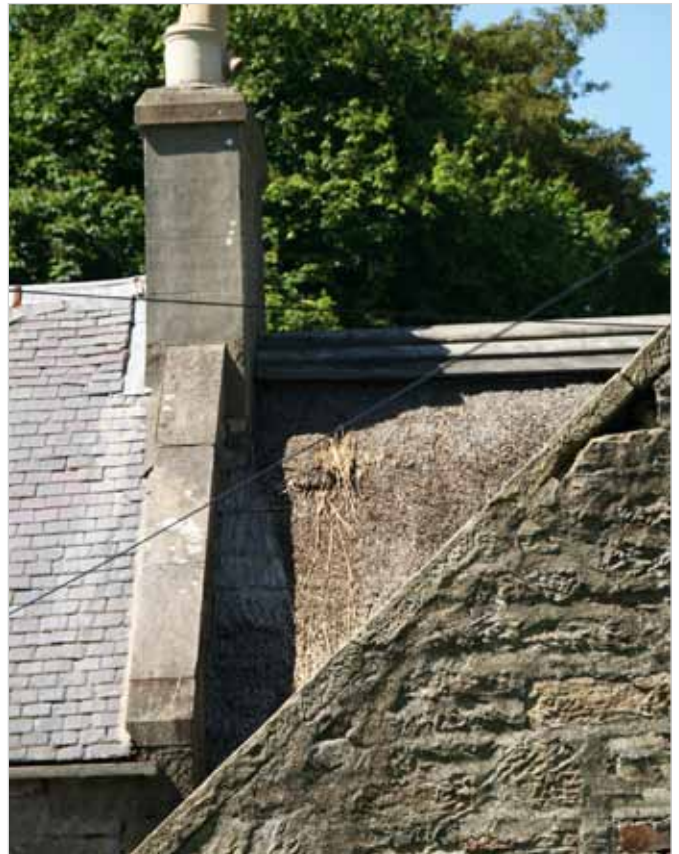
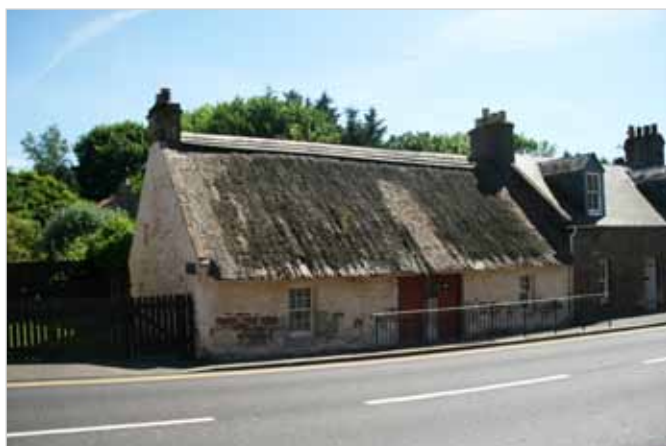
Souter Johnnie's Cottage – South Ayrshire

Condition of Thatch: ..... Fair

**Additional Notes:** Built in 1786, the cottage is owned by the National Trust for Scotland and is used as a museum. The three-tiered ridge is made of cedar wood, this type of wooden ridge being traditional in Ayrshire. The wheatstraw thatch has a heather underlay and the roof was last re-thatched circa 1996. The National Trust intends to re-thatch the roof, as well as the heather Ale House in the back garden, at some point in the next year. When the thatchers were re-thatching the roof at nearby Souter's Inn in 2013, two repairs were made to the roof of Souter's Cottage, one directly below each of the chimney stacks. The repair patches are scobed using hazel spars

and are also netted. The whole roof was previously netted; however, this was removed during the 2013 repairs. There is some deterioration to the surface of the thatch throughout, particularly to the north elevation, where some small plants have begun to grow out of the straw.

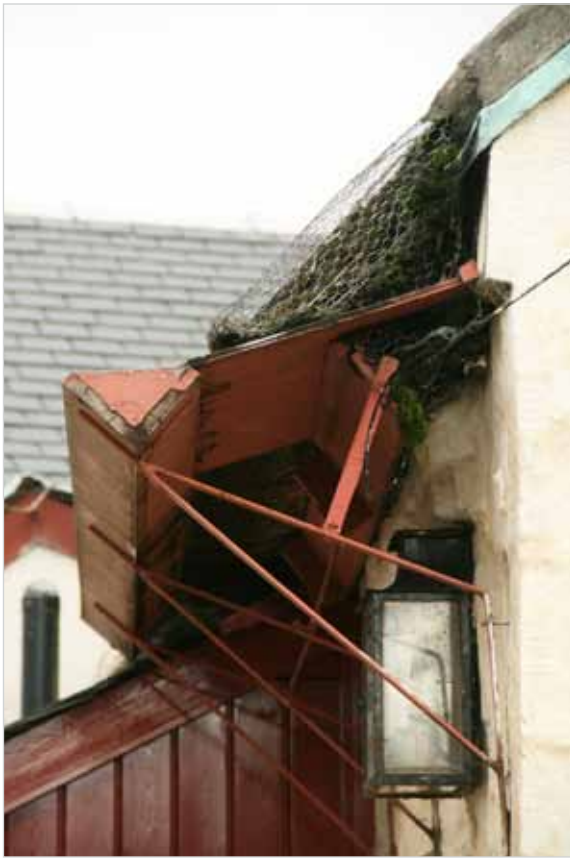
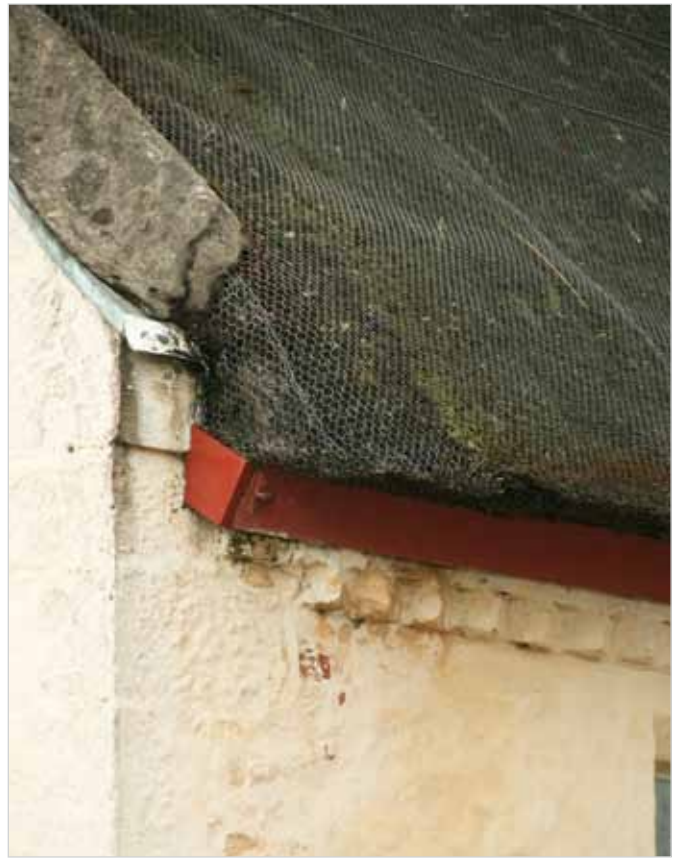
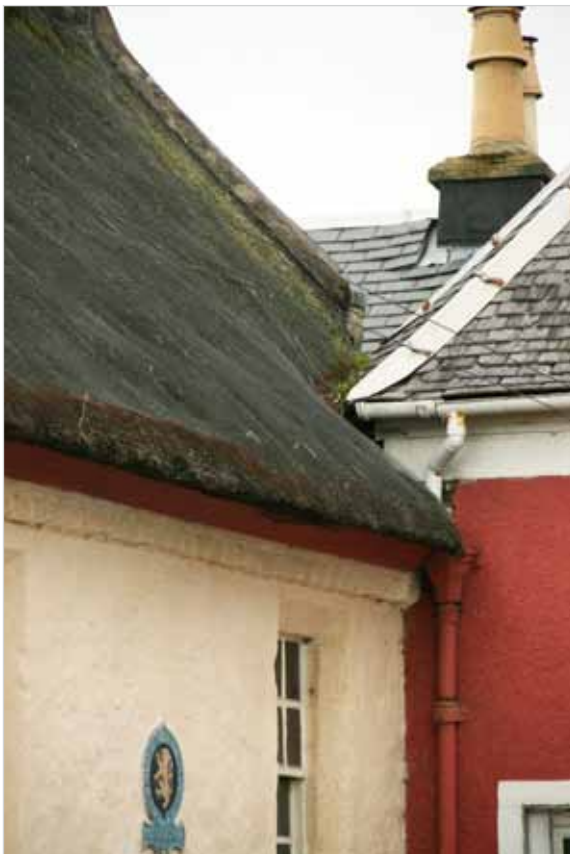
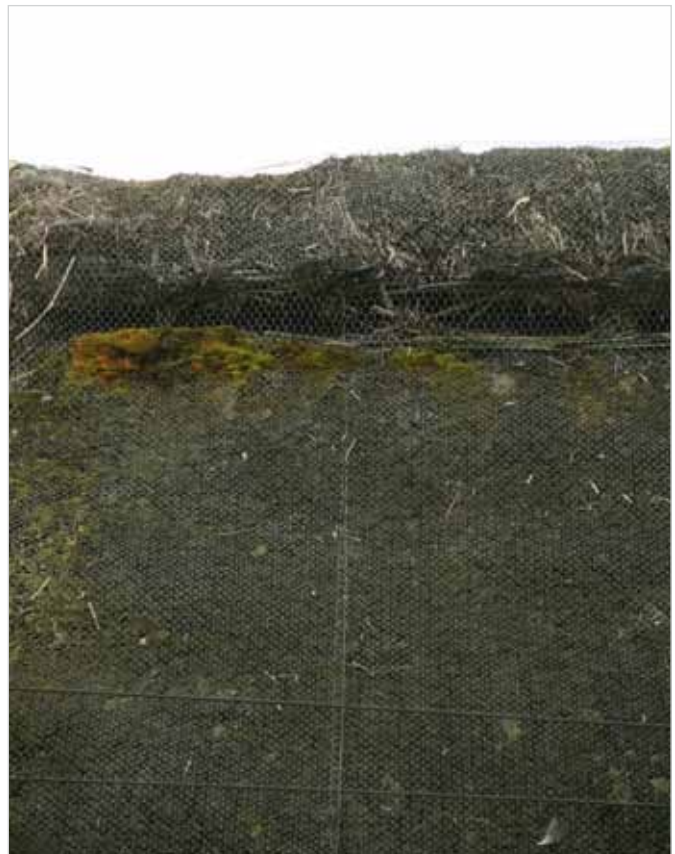
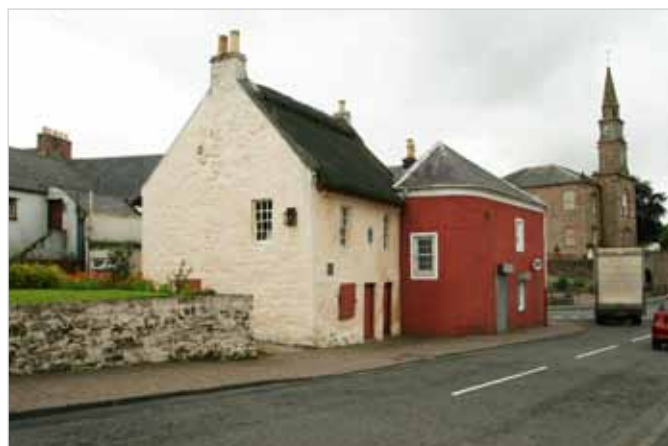
Burns Bachelors' Club – South Ayrshire

Condition of Thatch: Fair

underneath the eaves. The thatch has deteriorated

somewhat and the surface of the thatch is uneven.

some loose pieces of thatch, particularly along the

ridge.

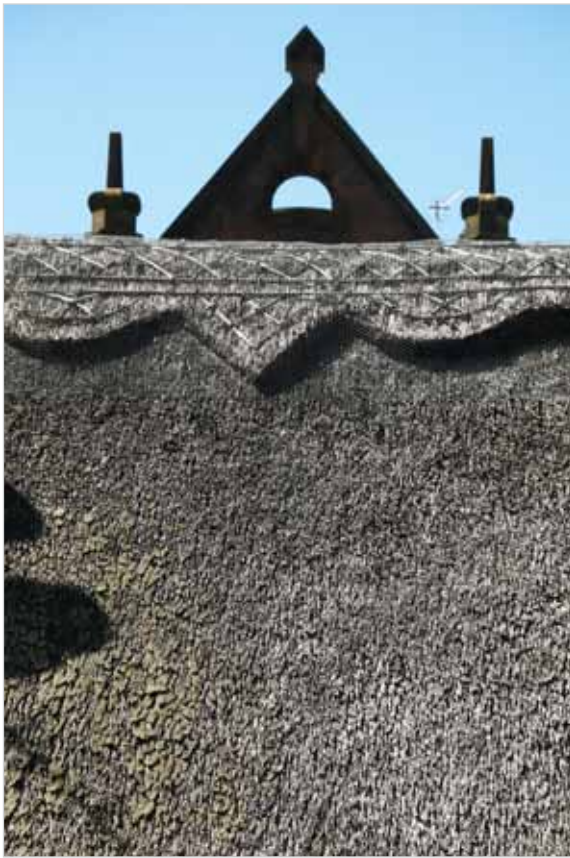
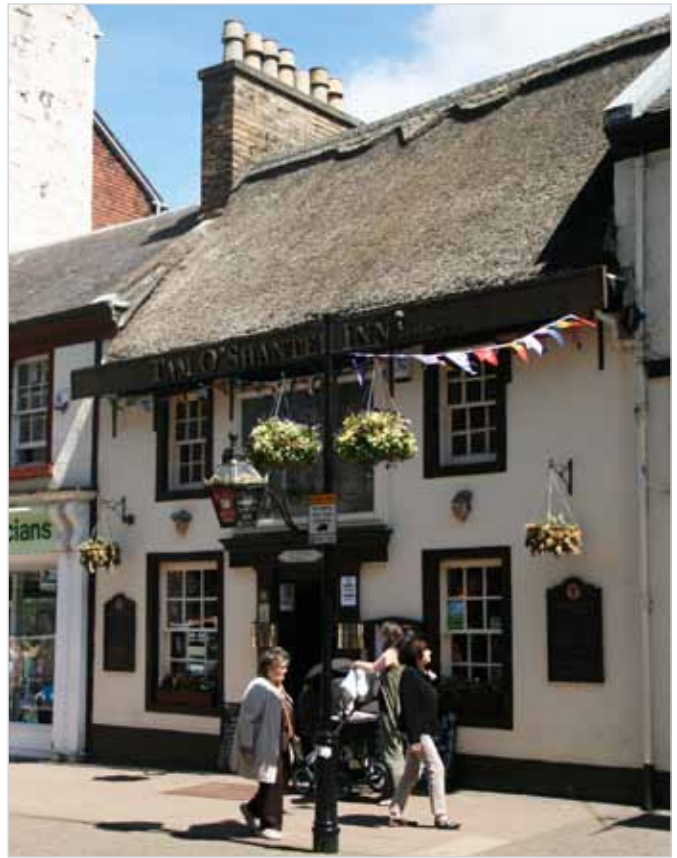
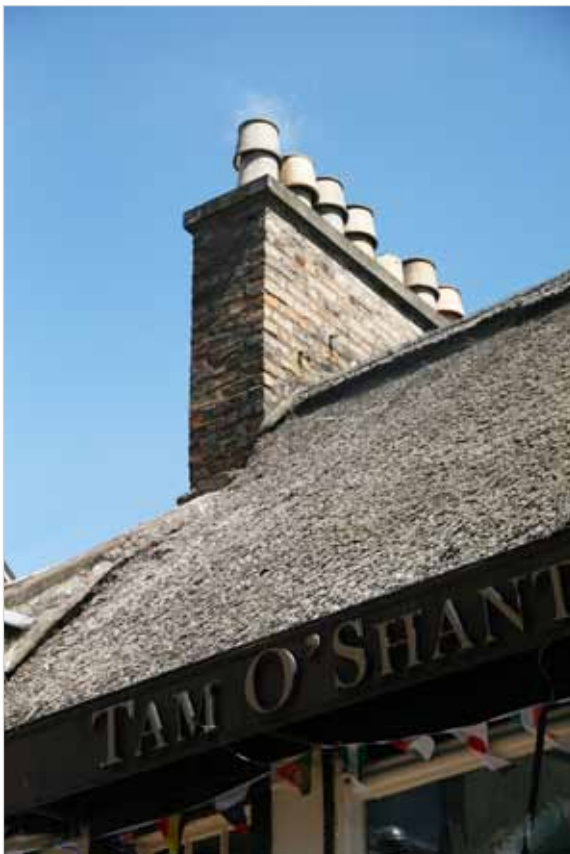
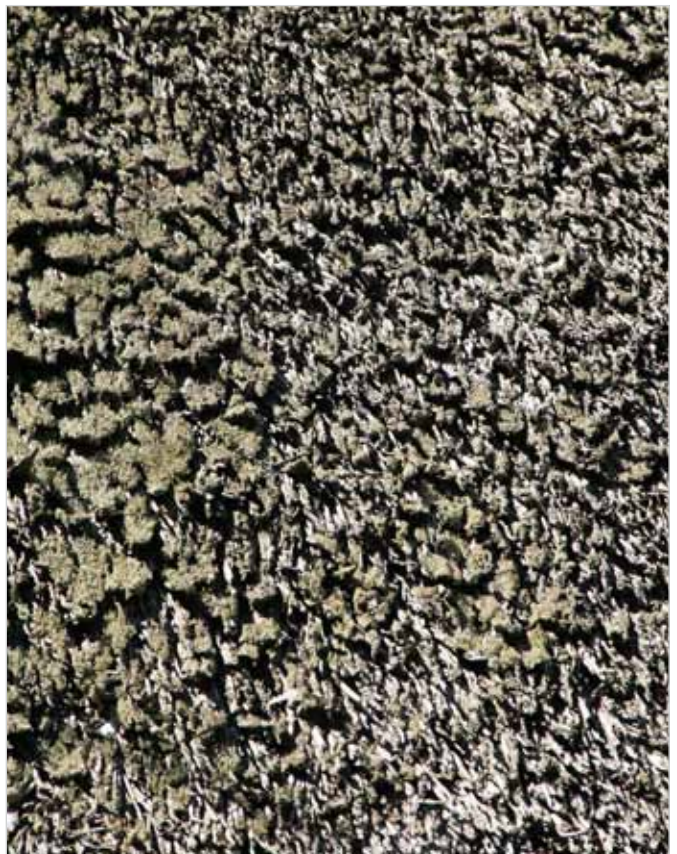
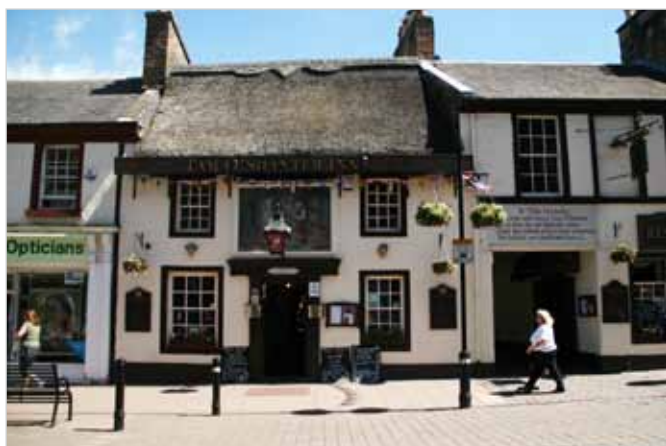
Tam O'Shanter Inn – South Ayrshire

Condition of Thatch: ..... Fair

Additional Notes: Two-storey inn rebuilt in 1808. Decorative, sculpted scobed ridge with hazel spars and horizontal metal wires/rods held in place by metal pegs. Listed as having a 'reed roof' and 'turf ridge'; however, both the roof and ridge are now thatched in reed. Only the ridge is netted, the rest of the thatch is uncovered. There is a fair amount of mossy vegetation growth throughout the thatch and some compaction/decay in places, most evident at the abutment to the later adjacent buildings.

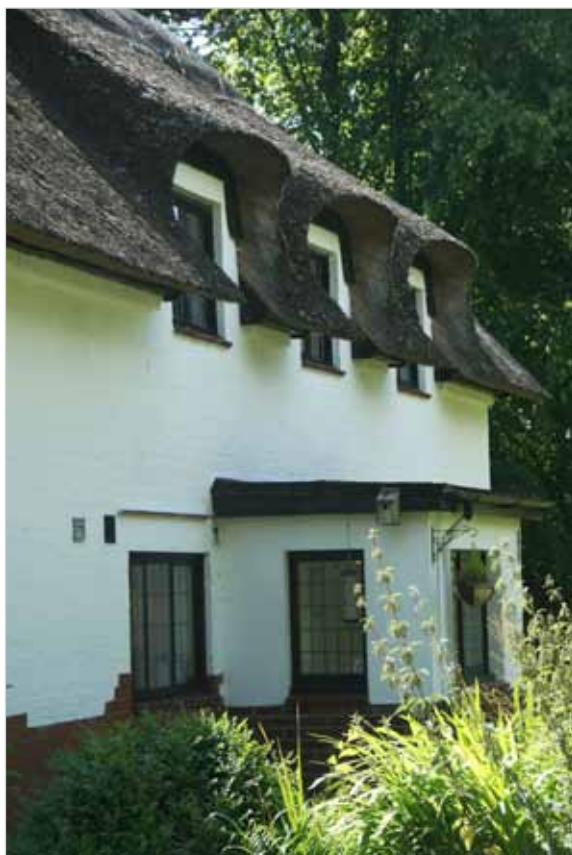
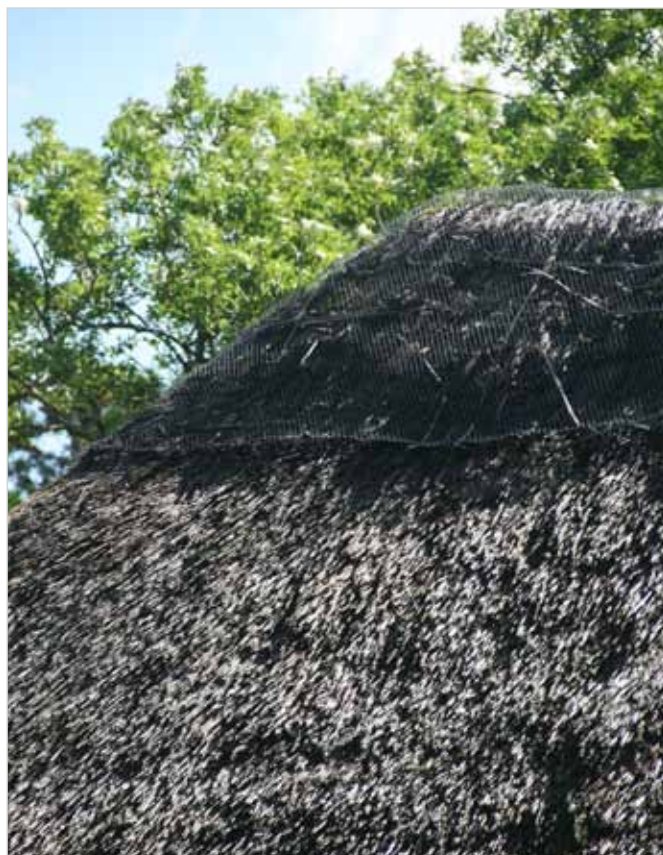
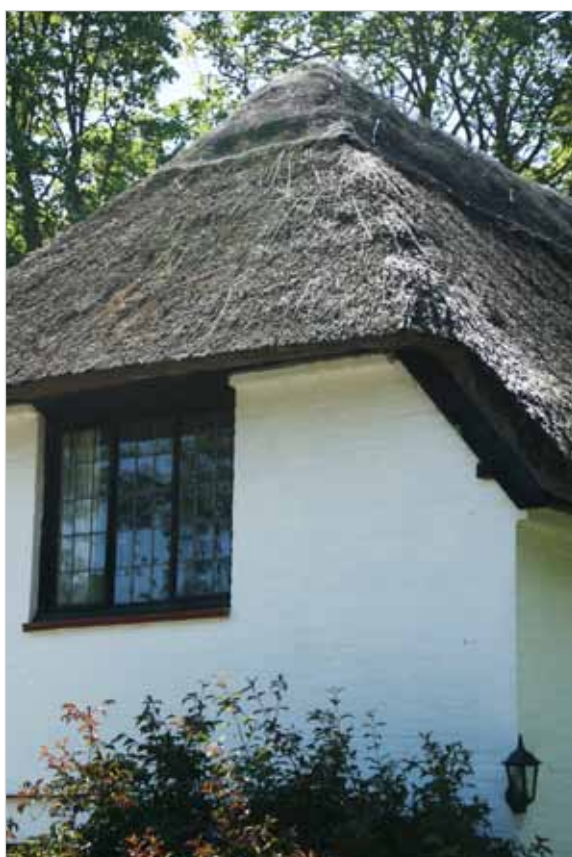
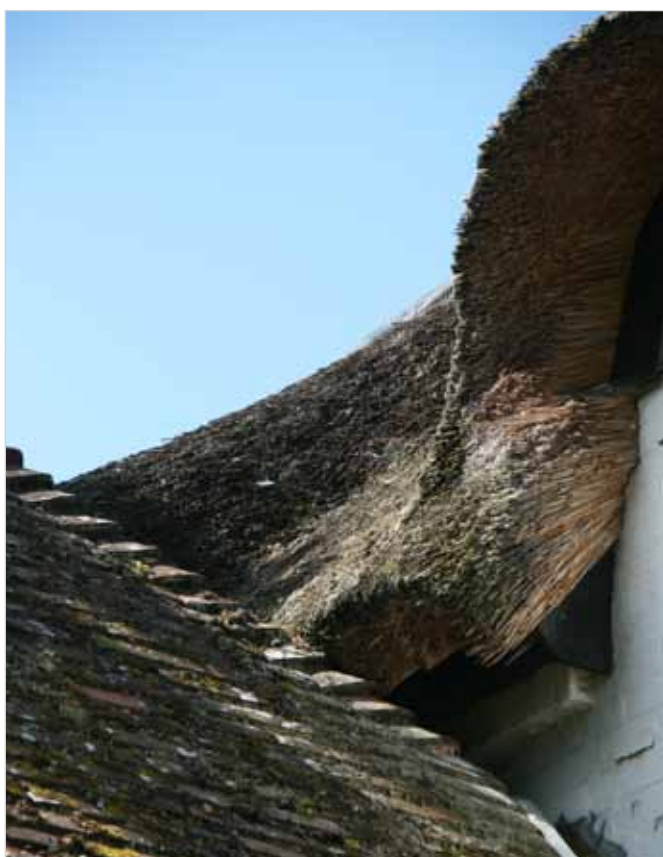
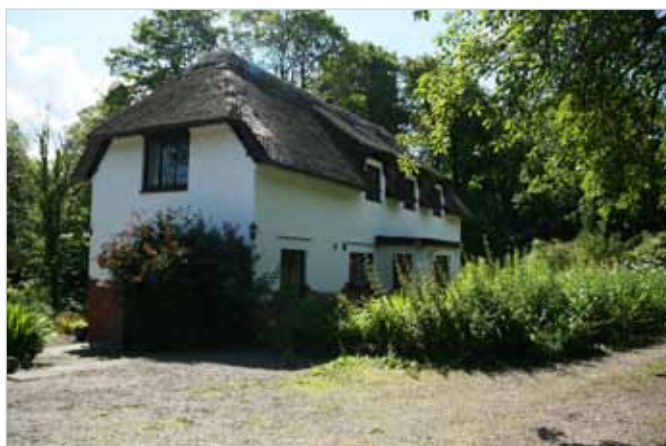
Doonbank Cottage – South Ayrshire

Condition of Thatch: ..... Good

Additional Notes: ..... The building is currently thatched in water reed, from Perthshire, and the ridge is thatched in straw. The roof was last thatched by a thatcher from Yorkshire around ten years ago (circa 2004). The owner of the building stated that the ridge is intended to be re-thatched again at some point in the next year. The ridge is netted whilst the rest of the thatch is uncovered. The thatch has a large overhang at the eaves and is moulded around the first-floor dormer windows on the east and west elevations. The thatch is in a good condition and has minimal signs of deterioration. The ridge, however, has deteriorated somewhat more, and much of the thatch

appears loose underneath the netting. The scobing has also come away from the ridge in many places.

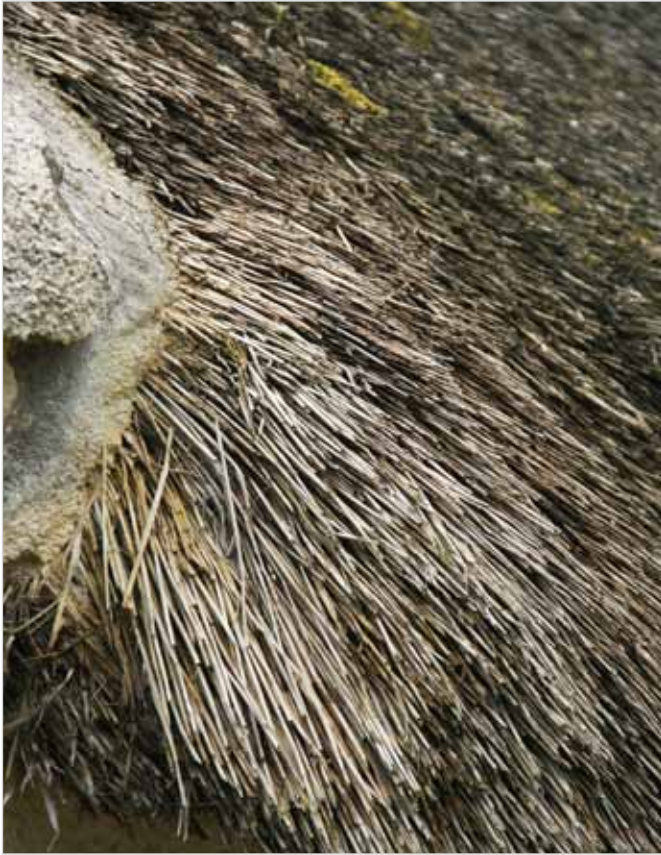
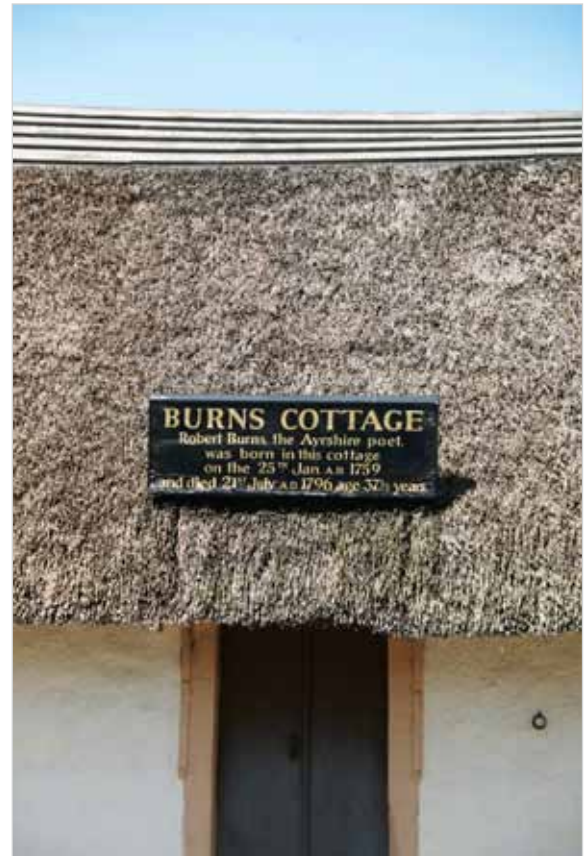
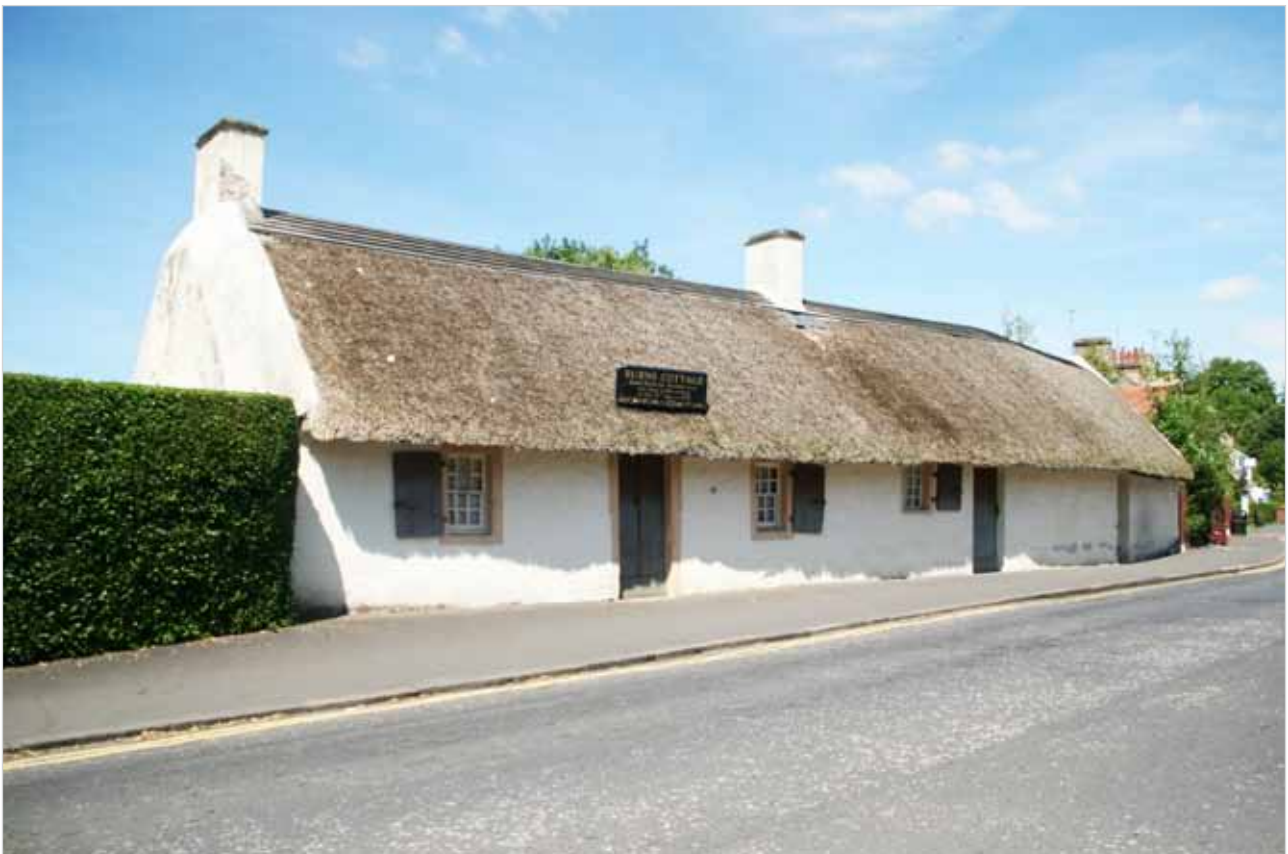
Burns Cottage – South Ayrshire

Condition: Good

**Additional Notes:** Single-storey, seven-bay cottage, built in 1737 and extended in 1808. The cottage was the birthplace of Robert Burns and is now part of the Robert Burns Birthplace Museum, which is run by the National Trust for Scotland. The building is of an almost rectangular plan (though slightly curved), and subsequent to its extension in 1808 it was used as an alehouse until 1880, 'when it was acquired and restored by the Burns Monument Trustees'. The building has a reed-thatched roof and a five-tiered (per elevation) timber plank ridge. This type of ridge appears to be a tradition for the area, and other buildings in Ayrshire still retain this type of material (e.g. Souter Johnnie's Cottage in Kirkoswald). The thatch has been left entirely uncovered and on the north elevation has a large amount of mossy vegetation growth across the surface of the reed, which has become quite dense in one area. The thatch has been left straight at the eaves along the south elevation, whilst on the north elevation the thatch has been sculpted slightly at the eaves over the top of the central window opening only.

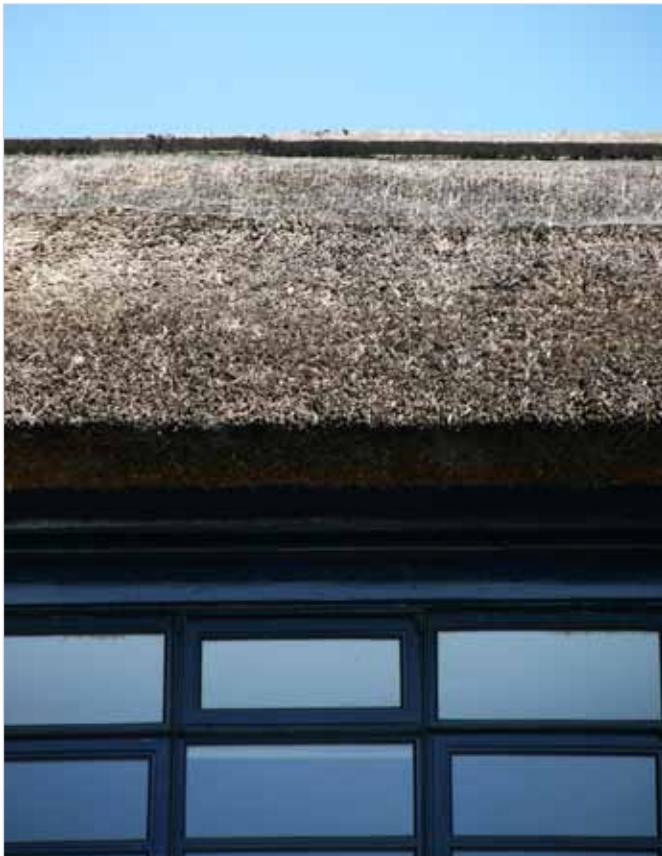
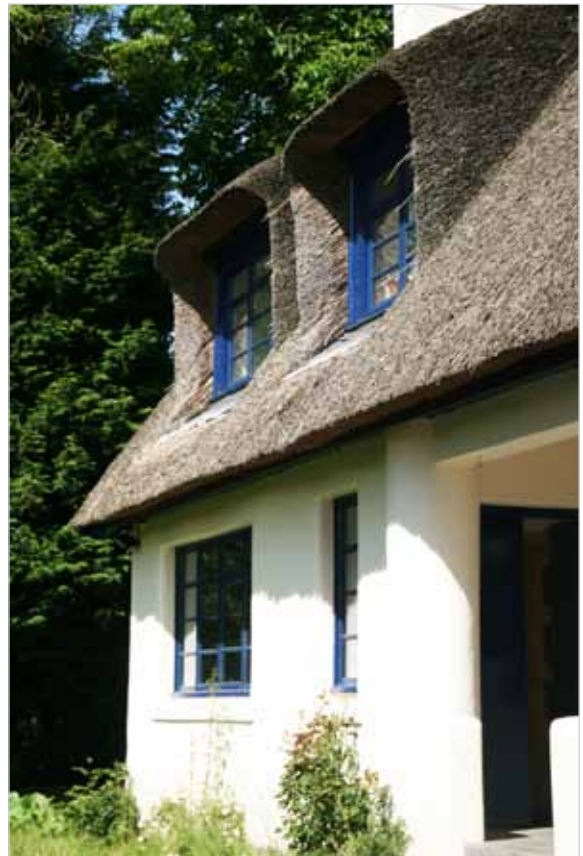
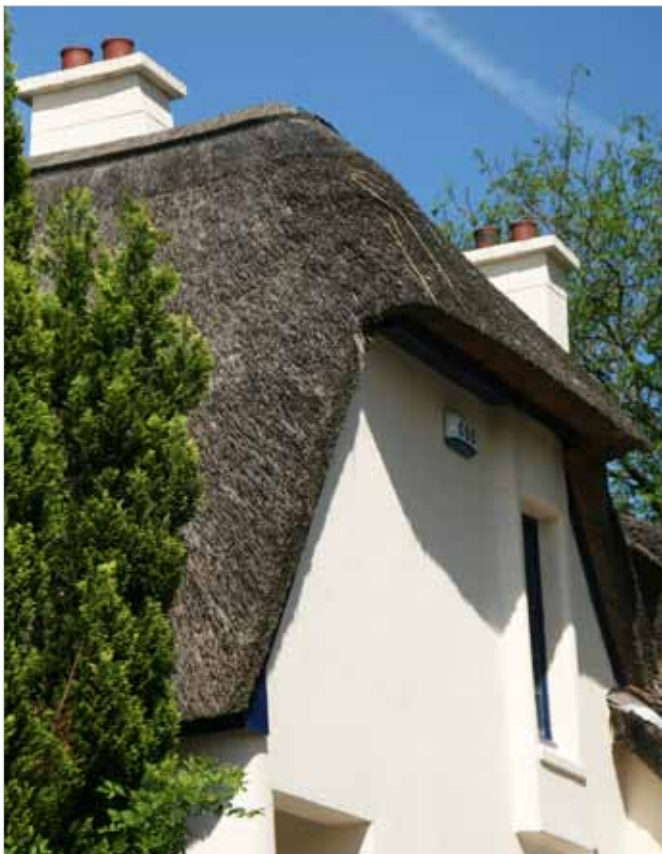
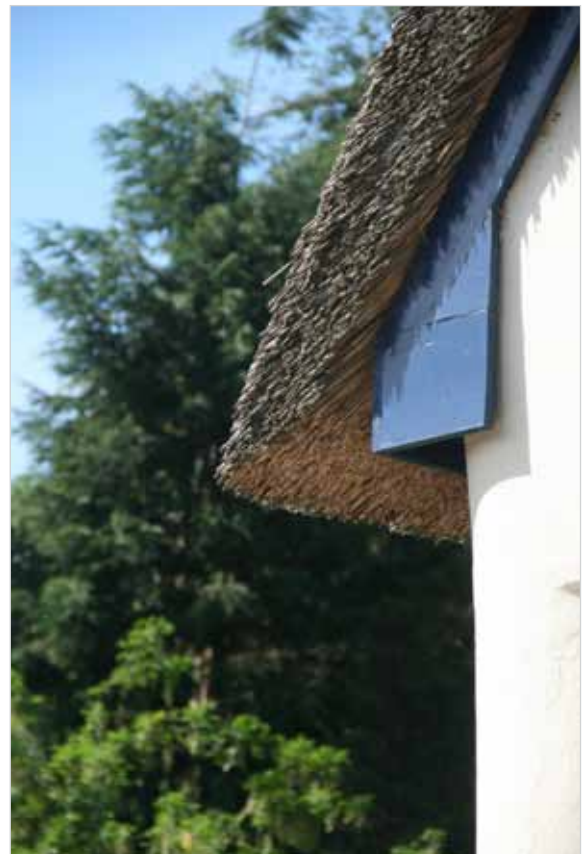
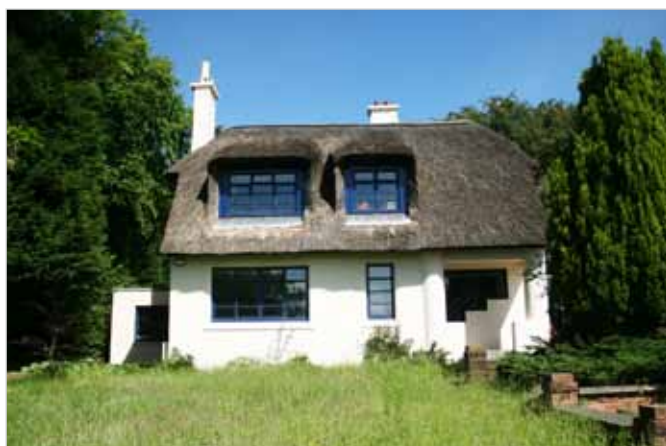
4 Newlands Place – South Lanarkshire

Condition of Thatch: ..... Good

**Additional Notes:** L-plan thatched bungalow with attic storey, and according to the listing description built circa 1935. The building has two attic dormer windows on the south-east (front) elevation and two in the north-east elevation. The thatch is netted directly below the raised concrete ridge, for approximately one foot, whilst the rest of the thatch is uncovered. The thatch is in good condition, although perhaps a little untidy in places with a few loose pieces of reed. A tenant of the building believed it had last been thatched in the late 1980s and had recently been advised by the owner that it was due to be re-thatched at some point within the next

two years. The building is currently being let to an architecture practice.

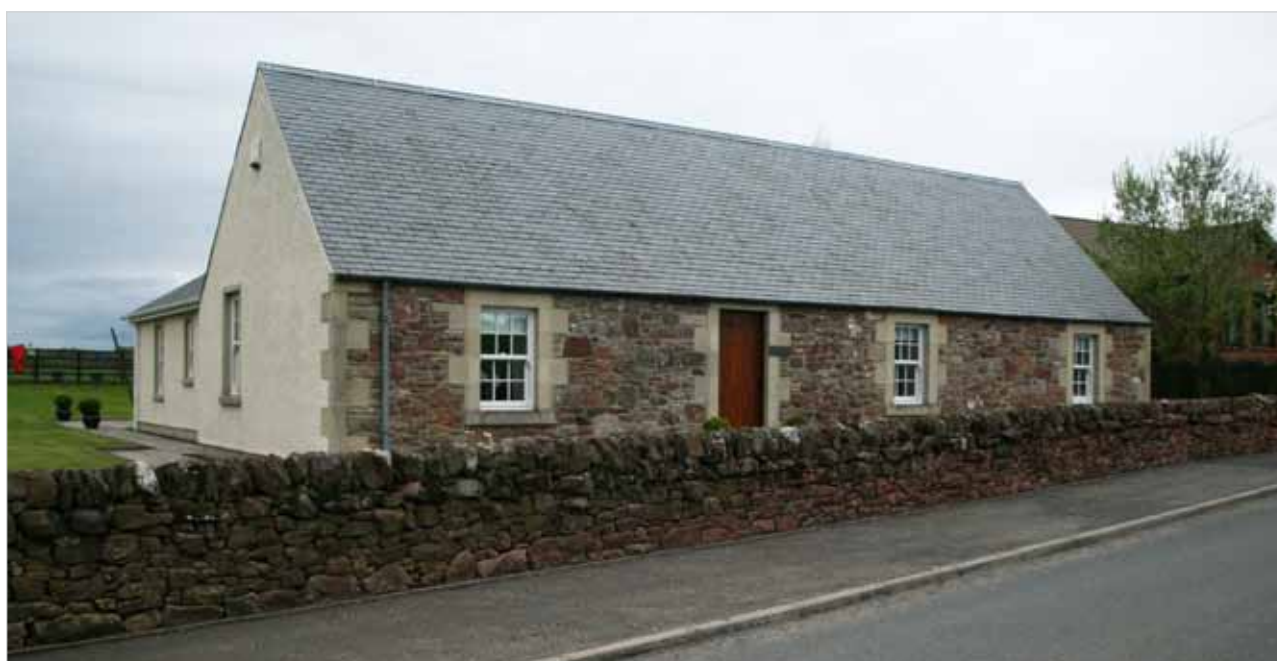
Address: ..... Dunsyre Road

**Additional Notes:** ..... The listing description for this property states that it is '*thatched beneath a corrugated sheet metal covering*', and that the thatch is visible internally beneath the sheeting. The building appears to have been renovated and extended since being listed (the building plan from Canmore is different to the current plan), and is now slated. The property is now called 'View Kern', according to signage on the front of the building. Unable to locate planning application documents to ascertain what, if any, of the original building was retained. Further research into this building is required and the listing description should be updated accordingly.
